**NATIONAL BUREAU OF STANDARDS REPORT**

3321

FIRE TEST OF PLASTIC, UNIMPROVED

CONCRETE RUST BLINDS

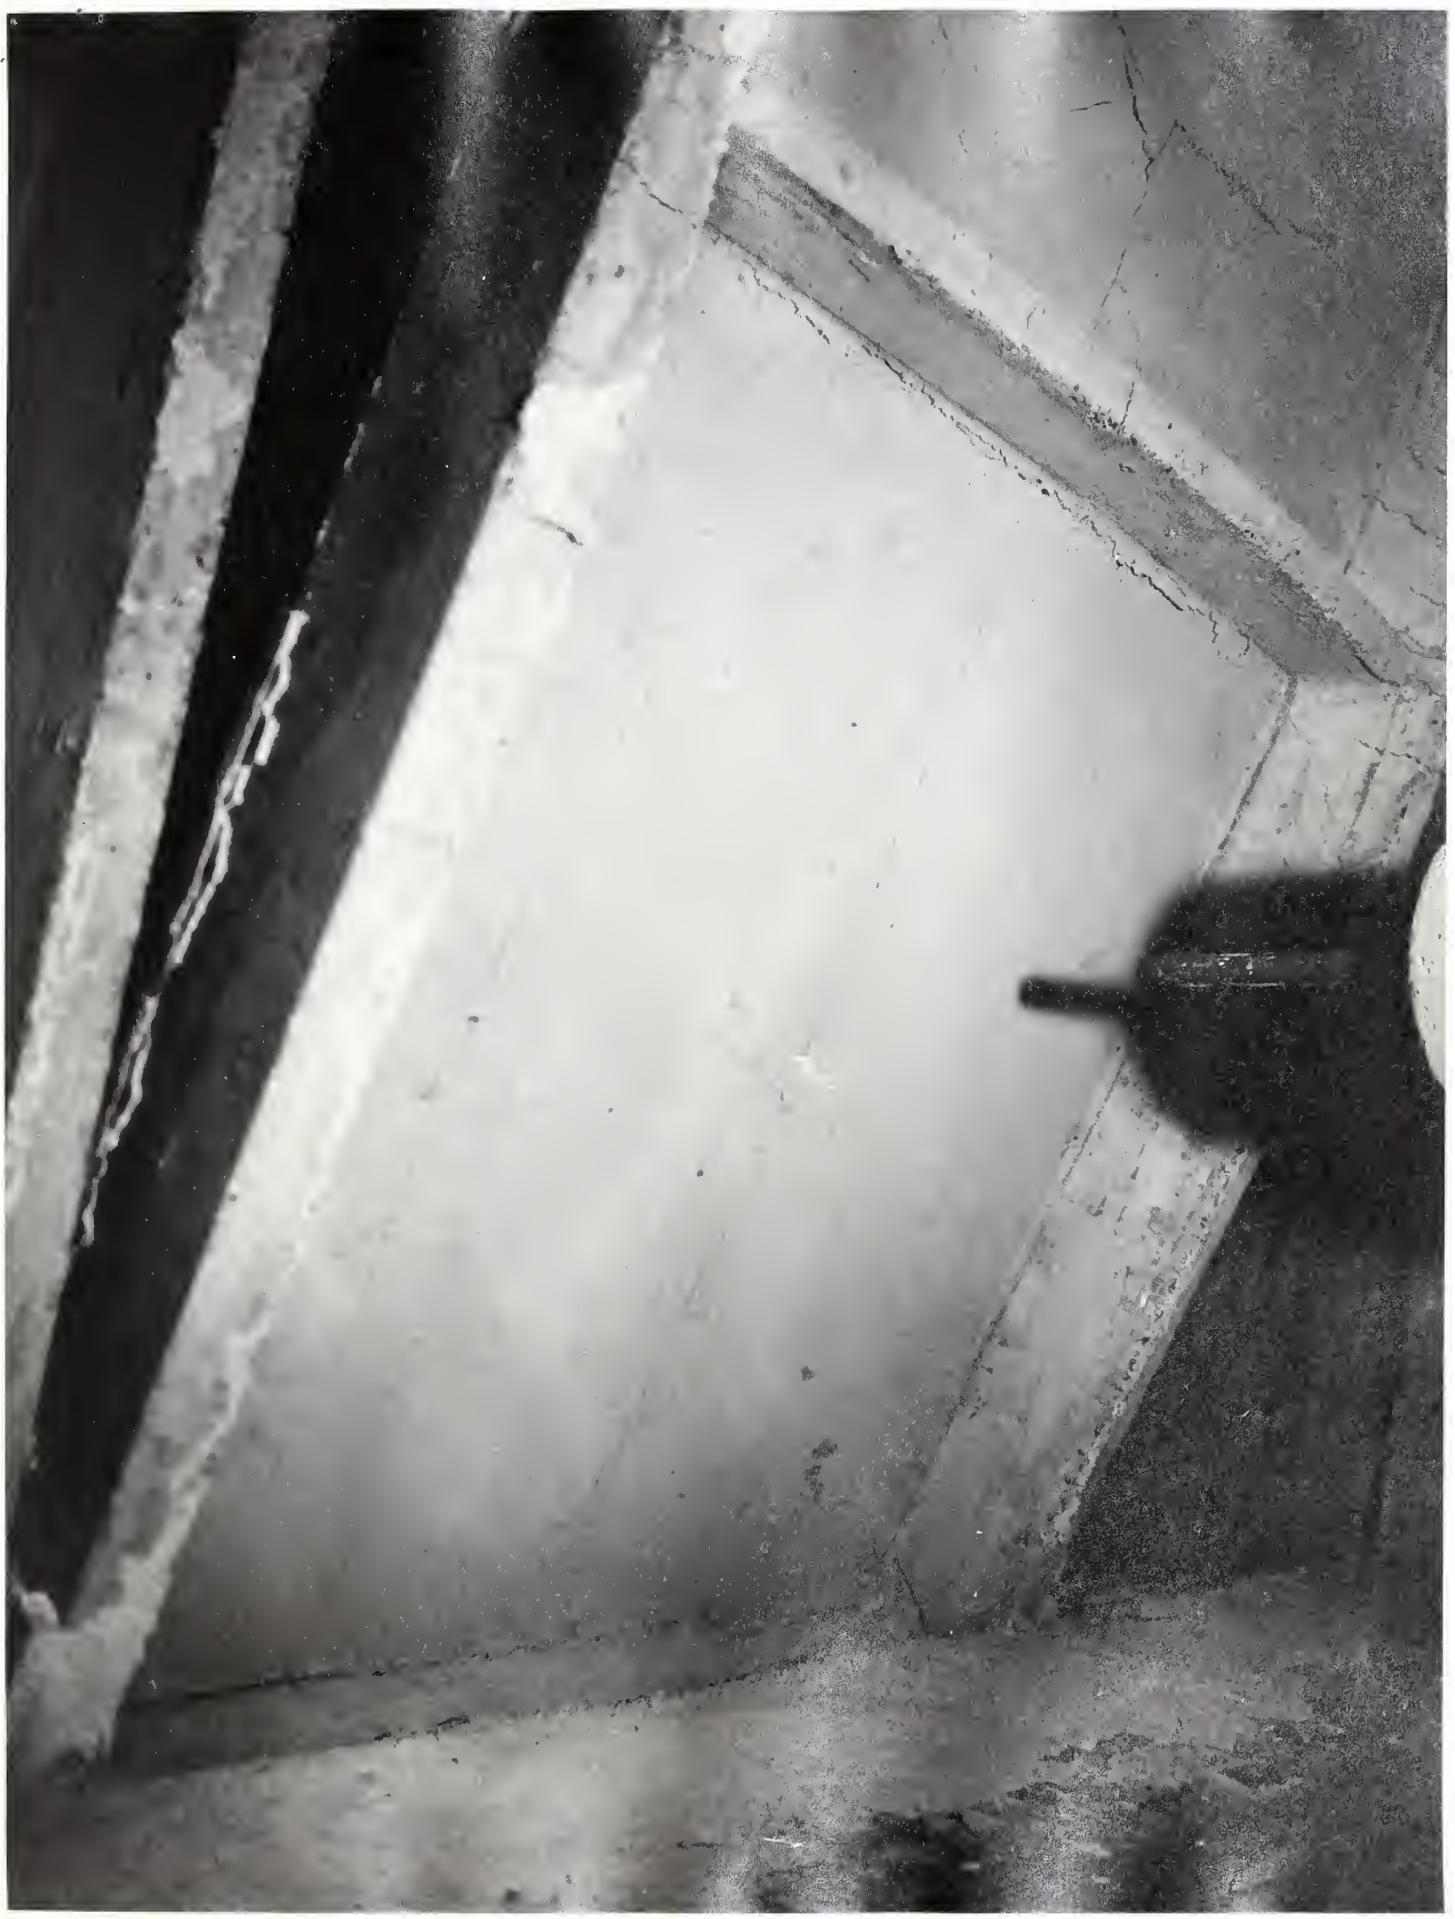
Fig. 7. North end of center slab, exposed face
